RECLAIMING PALMER 2020

History Palmer Chairlift Timberline Lodge

Reclaiming Palmer-Weather/Safety

PNSAA Conference

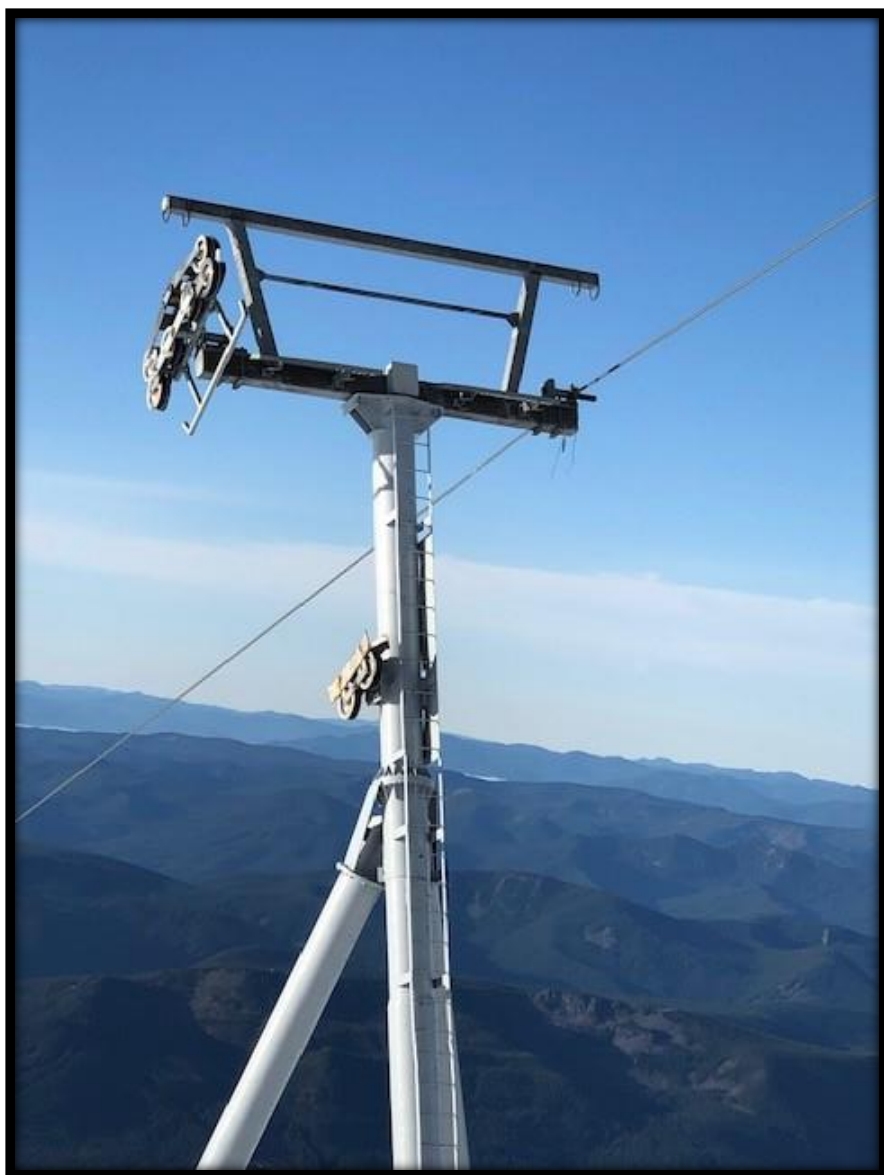
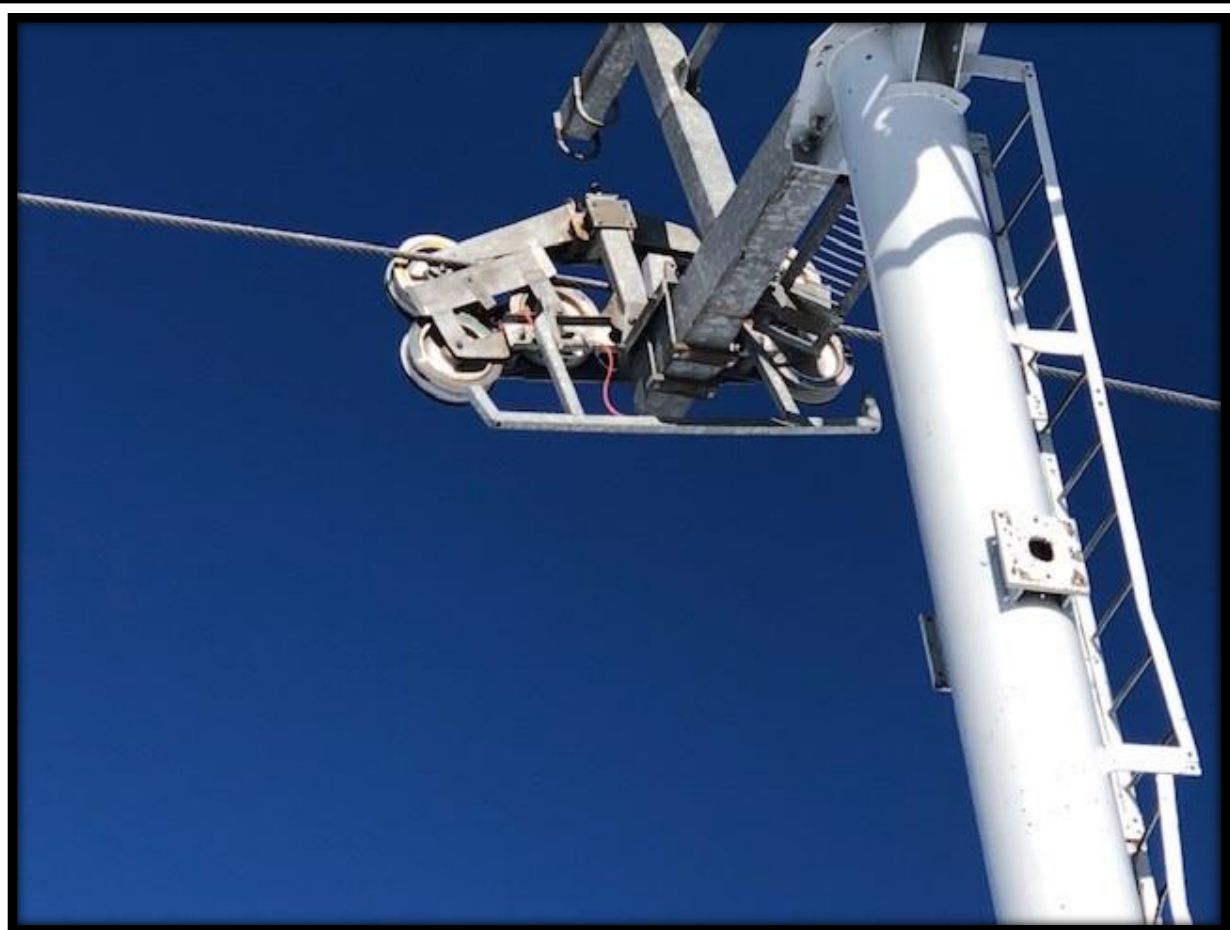
- ▶ October 16th, 2019 – early season snow storm; began with rain and wind ended with 3' snow accumulation at 6000'. Heavy ice build up on Magic Mile and Palmer. Could not assess.
- ▶ October 20th, 2019 Opened Pucci & Bruno for 1 day. Magic Mile de-roped HS TWR 16,17,19,20 due to wind and ice build up. Palmer de-roped numerous locations with the HS assembly of TWR 20 on the ground.
- ▶ October 24th, 2019 TWR 20 assembly replaced and all Palmer de-ropements recovered.

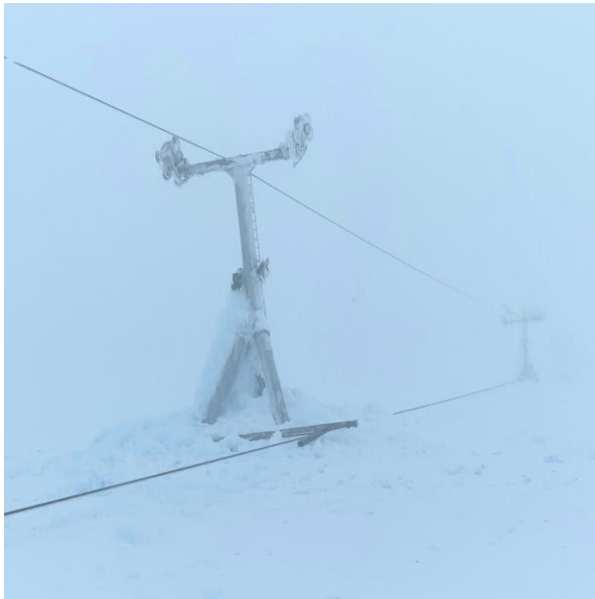
Tower 21

February 7th, 2020

- ▶ In total we were de-rope on 23 assemblies
- ▶ Lost two tower crossarms and lifting frames
- ▶ Haul rope needed replaced
- ▶ 15 assemblies needed to be pulled and rebuilt
- ▶ Tower cap bolts and console bolts needed replaced
- ▶ Electrical work

- ▶ May 7th we flew tower crossarms to towers 21 and 22
- ▶ May 15th the ski area re-opened for the public, Stormin Norman and the Magic Mile
- ▶ May 24th project “new rope” commenced with the help of Doppelmayr USA
- ▶ May 30th splice project complete
- ▶ Early June, annual pre-op work and electrical completed

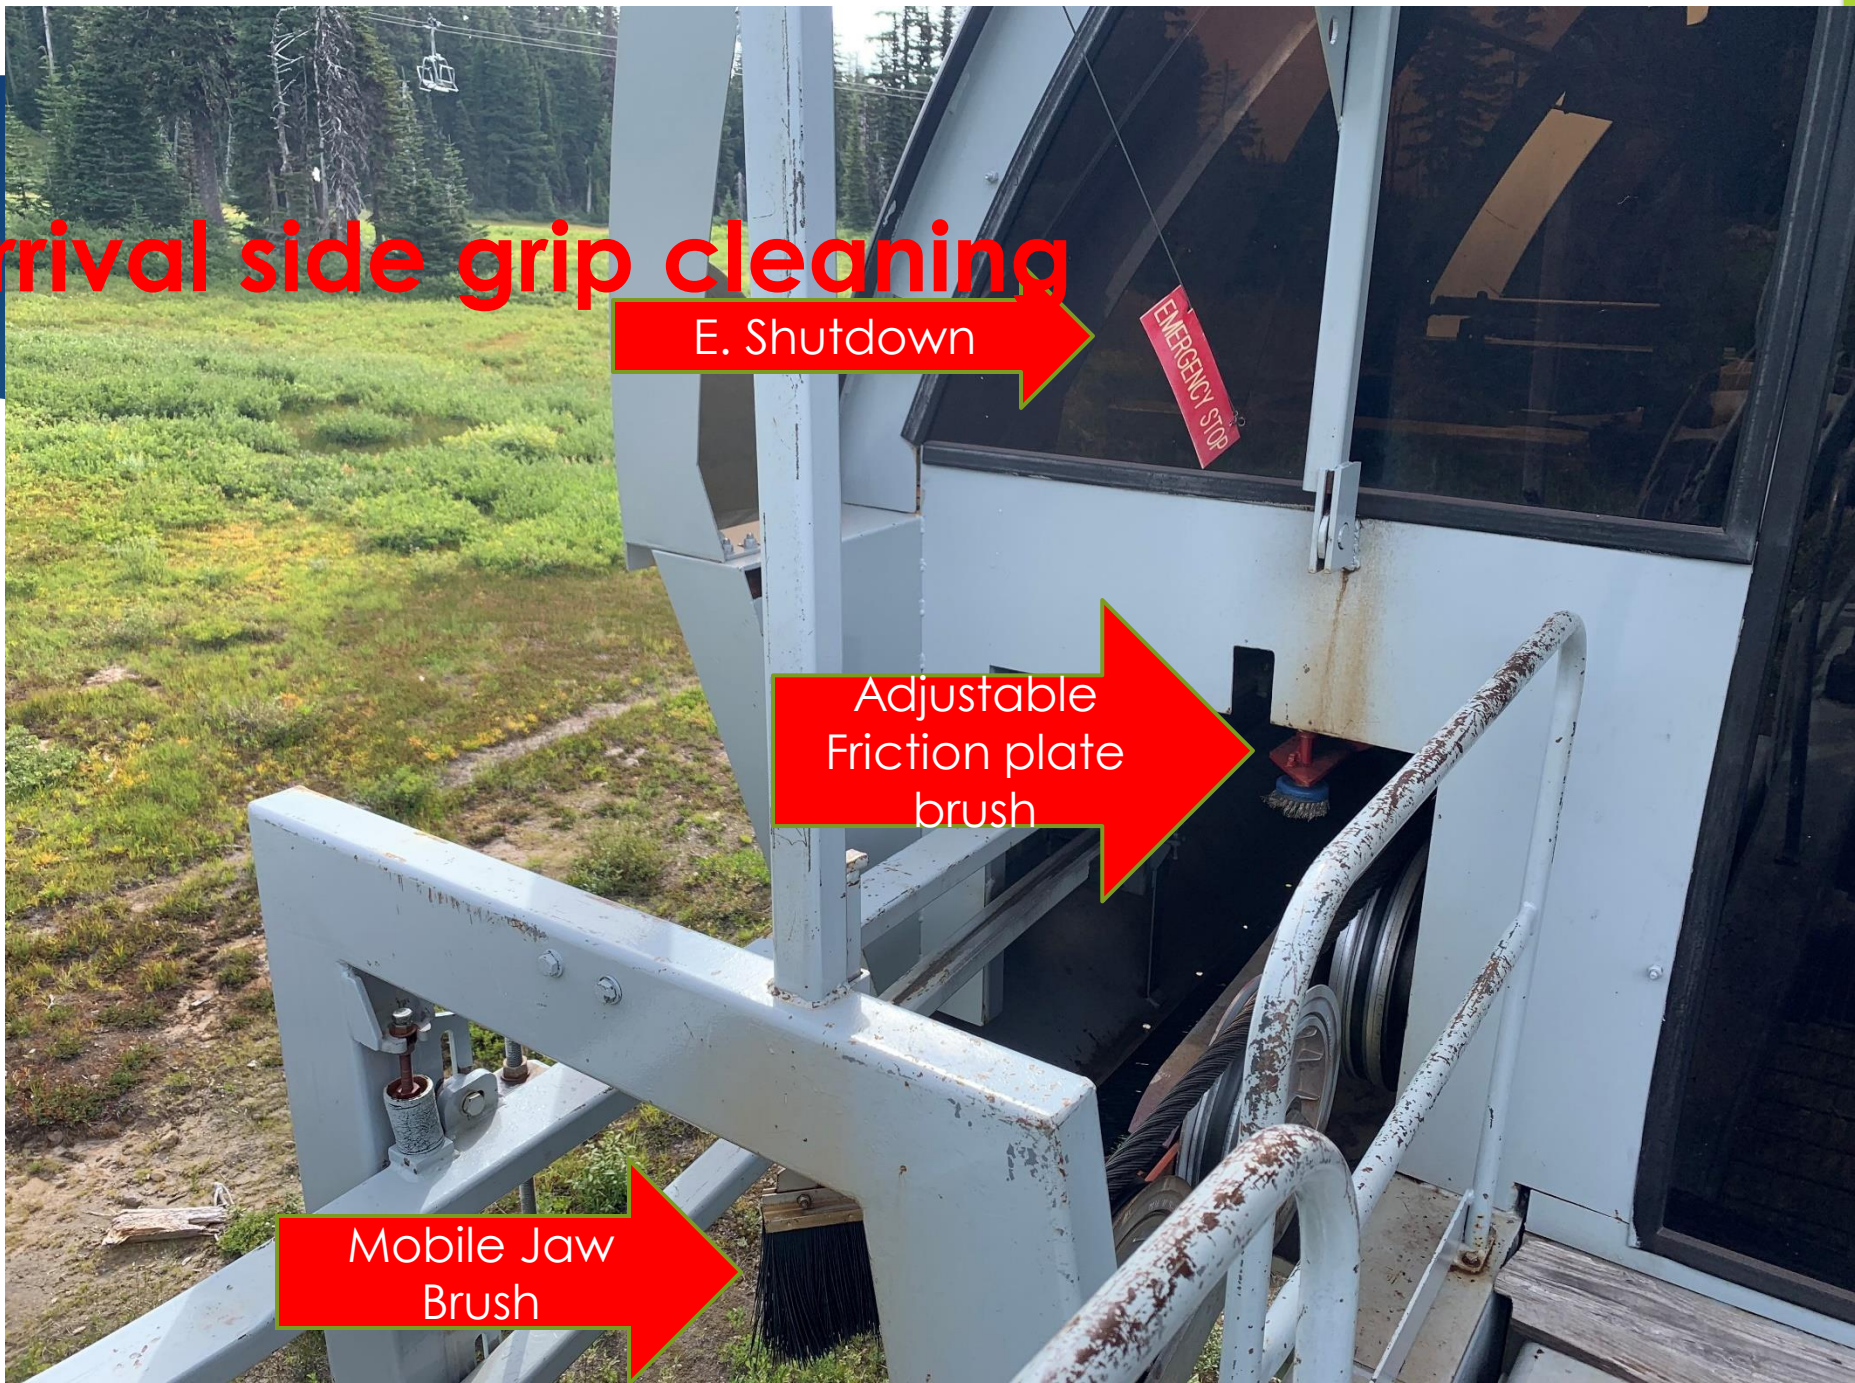
Tools-Adjustable Friction Plate Brush

Arrival side grip cleaning

Adjustable
Friction plate
brush

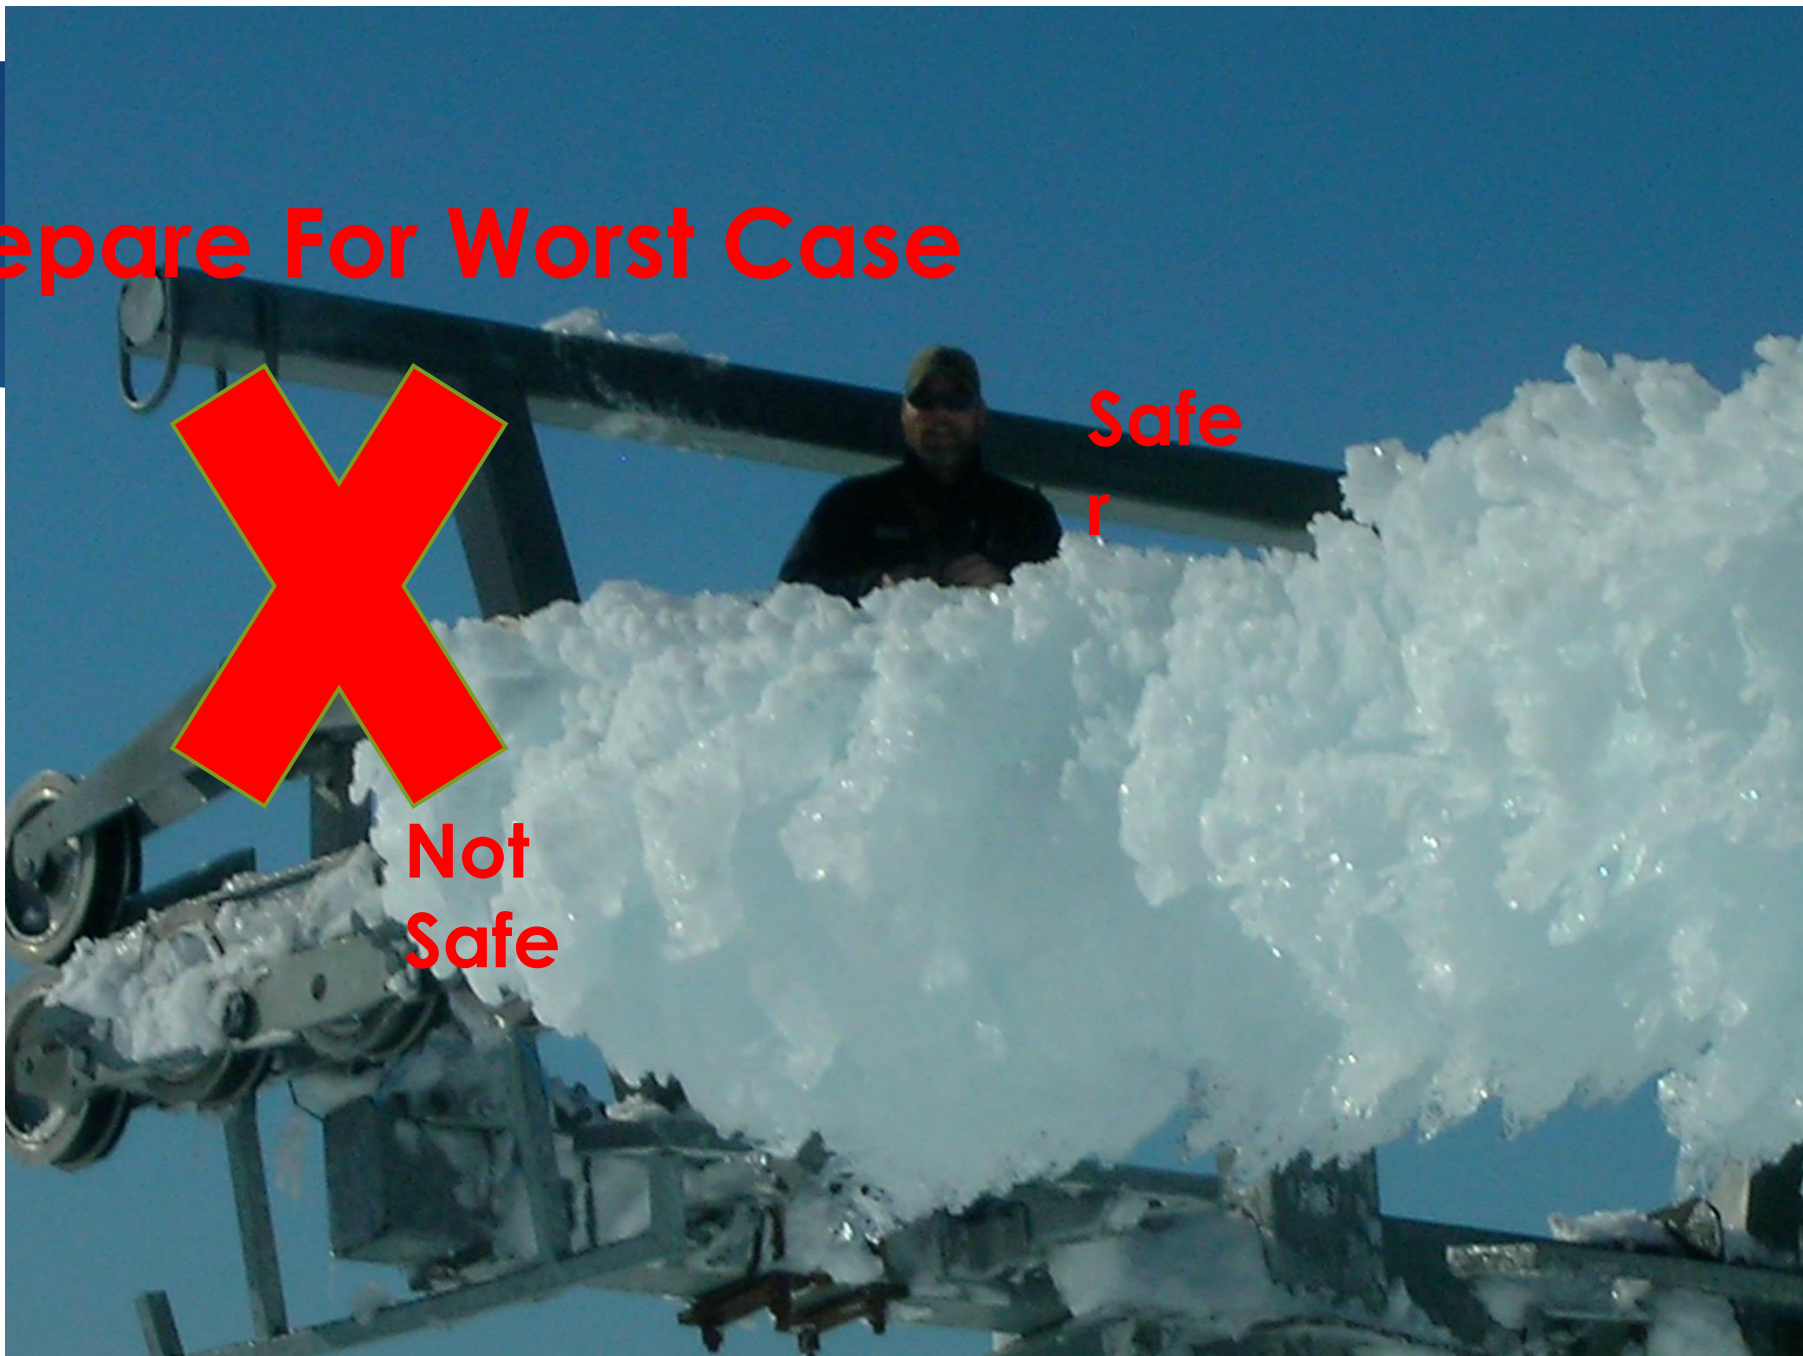
Labor Intensive Method

- ▶ Time and Labor
- ▶ Crew morale and safety
- ▶ Dangerous positions if derailment occurs
- ▶ Falls possible/rescue plan details crucial
- ▶ Communication critical-radio breaks, dead battery, safe states, lockout procedures
- ▶ Management and guest pressure?
